**Full-Scale Testing and Progressive Damage Modeling of  
Sandwich Composite Aircraft Fuselage Structure**

A Thesis

Drexel University

October 2010

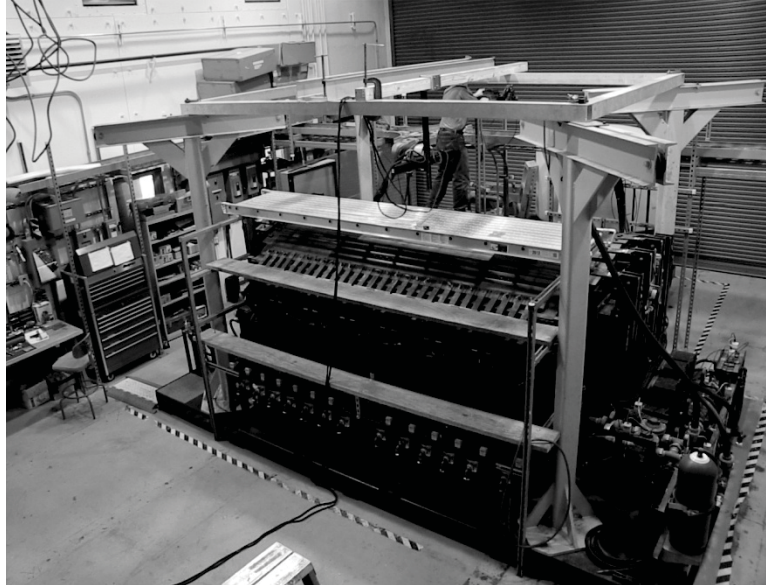
Figure 3.1. General view of FASTER fixture.

The testing of the composite fuselage panels was conducted at the Full-Scale Aircraft Structural Test Evaluation and Research (FASTER) facility, located at the Federal Aviation Administration (FAA) William J. Hughes Technical Center, Atlantic City International Airport, NJ. The FASTER fixture is capable of subjecting full-scale curved fuselage panels to loadings representative of those experienced by a narrow-body aircraft under actual operating conditions for either long-term fatigue or quasi-static residual strength loading conditions. A general view of the FASTER fixture can be seen in Figure 3.1.

The FASTER fixture features a unique adaptation of mechanical, fluid, and electronic components and is capable of applying internal pressurization, hoop, longitudinal, and shear loads to a fuselage panel. The panel is set on top of a D-shaped pressure box and bonded with an elastomeric seal. The system is capable of using either air or water as the pressurizing medium, although water was used in each of the composite panel tests. Hoop- and longitudinal-edge loads are applied to the panel by 14 hoop and 8 longitudinal computer-controlled loader arms. Each loader arm consists of a water actuator, a lever arm, a fulcrum, a load cell, and a whiffle tree,

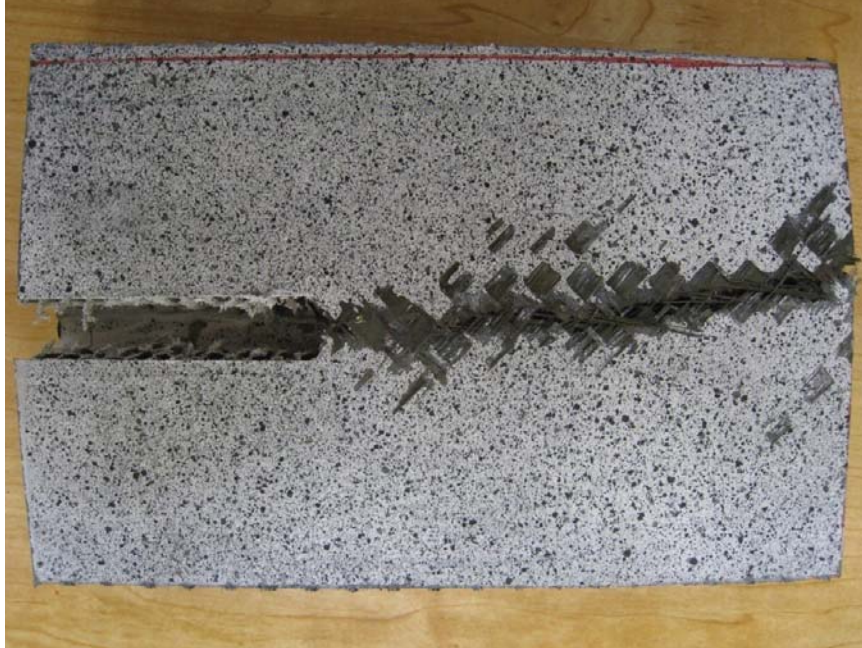
Figure 5.19. The exterior view of the notch tip of panel CP5 that was monitored by the DIC system, showing the notch and the fracture emanating from the notch tip propagating from left to right through the face sheet material.

The sample was approximately 0.625 inch in the longitudinal direction and 0.625 inch in the hoop direction, and included the interior face sheet and the honeycomb core. The exterior face sheet was not examined due to excessive damage. Figure 5.19 shows the posttest exterior face sheet notch tip damage. Figure 5.20 and Figure 5.21 show the SEM specimen before and after being cut down to size, respectively. Clearly, some fibers are missing in Figure 5.21 that were present in Figure 5.20; these fibers were loose and were removed so as not to damage the microscope during the examination. Fiber imprints on the sample will later reveal where these fibers were located. Much of the material at the fracture surface was either lost during the sudden, dynamic fracture of the panel or connected to the opposite fracture surface

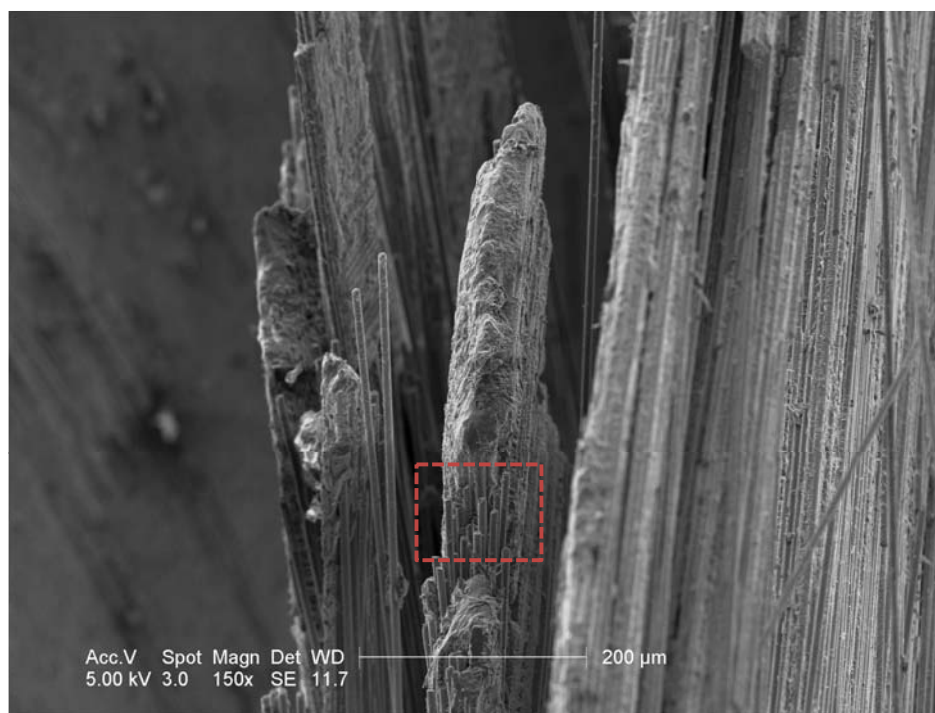
Figure 5.26. SEM image of fiber fractures of 45° fibers.

As was observed in the catastrophic fracture of each of the panels, fiber fractures along the major fracture of the panel caused widespread matrix cracking and damage to the plain-weave fabric, extending several inches on either side of the fracture (e.g., Figure 4.37). In the immediate vicinity of the notch tip, the most predominant occurrence of fiber fracture was in the fibers perpendicular to the notch (i.e., the  $90^\circ$  fibers), Figure 5.25. The initial failure of the  $90^\circ$  fiber tows redistributed the load to the  $\pm 45^\circ$  fibers of the neighboring laminae, causing collateral damage to them, as discussed in Section 4.3.3. An example of  $\pm 45^\circ$  fiber fracture is presented in Figure 5.26, with a close-up view in Figure 5.27.
